## **Deploying the Heavy Assault Bridge: Lessons Learned in Operation Iraqi Freedom**

### **重裝突擊橋之佈署:伊拉克自由行動之經驗教訓**

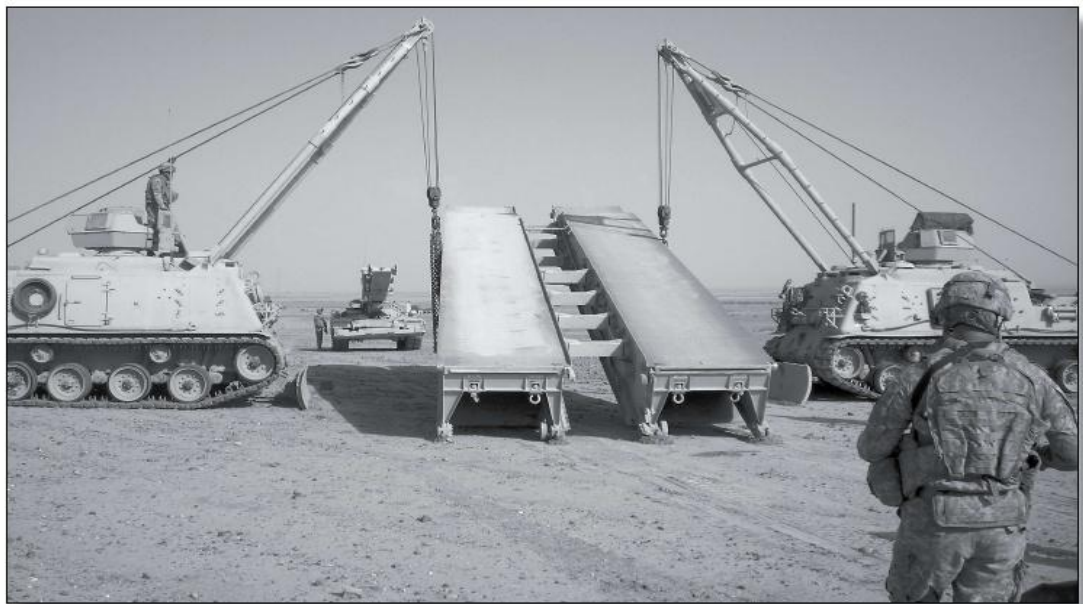
Operators use armored recovery vehicles to suspend the HAB in preparation for attachment to the Wolverine in the background.

背景來自於操作者使用裝甲救濟車來支援重裝突擊橋組裝在金鋼狼上的準備工作。

As the team explored the unfamiliar procedure for using M88A2 booms to lift, suspend, and fix the folded HAB to the M1 Abrams tank chassis of the Wolverine over the next 6 hours, mission tempo ground to a halt. In the process, the operators damaged components of the Wolverine carrying arm

system, jeopardizing mission success. After much trial and error, the engineers attached the bridge, while the C Troop first sergeant (a career tanker) instructed the novice crew on Wolverine movement operations. At this point, the convoy split into two sections. The four HETs and four gun trucks moved to an alternate TAA, while the remaining gun trucks, the explosive ordnance disposal team, the two armored recovery vehicles, and the Wolverine carrying the HAB proceeded east toward the bridging site at Al Awashra. After 2 hours of deliberate travel through restrictive terrain, the patrol arrived at the site as darkness fell.

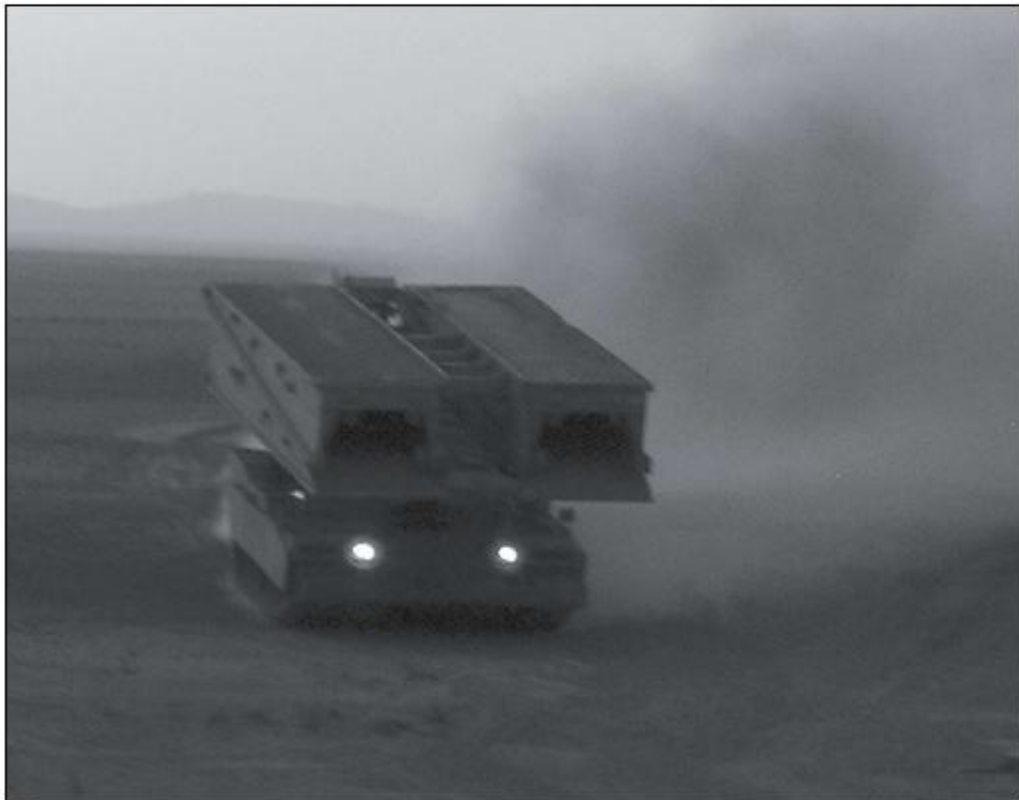
The Wolverine, with the HAB in place, maneuvers to the bridging site.

搭載重裝突擊橋的金鋼狼前往架橋現場的機動畫面。

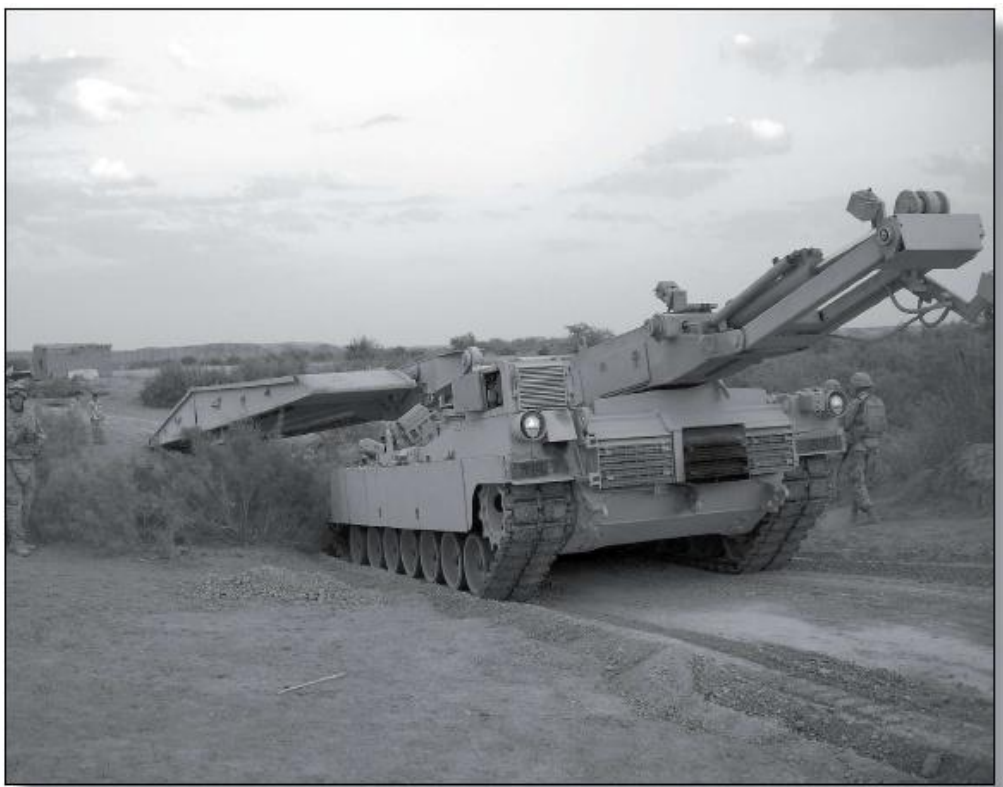
The Wolverine emplaces the HAB as coalition partners look on.

安置重裝突擊橋的金鋼狼被當成同盟夥伴看待。

The arrival of the team at Al Awashra initiated the final phase of the operation: bridge installation. With the Iraqi partners on-site to assist with security, the explosive ordnance disposal team cleared the site of potential explosives and the engineers positioned the Wolverine to extend the HAB. Unfortunately, after numerous attempts to use the launch system to extend the bridge over the river further damaged components of the supporting arm, the device was inoperative. The process of attaching the bridge to the Wolverine carrying arm had taken its toll. Complicating the situation further, the HAB could not be fully retracted and had to be abandoned near the site. With the mission now unachievable, the team reunited with the transportation element at the alternate TAA, uploaded the disabled Wolverine and M88A2 vehicles onto the HETs, and returned to Forward Operating Base Warrior. Two days later, the Balad elements returned to home base.

Despite additional damage to interlocking components on the bridge, which prevented the system from functioning properly, this time the Soldiers repaired the structure by cannibalizing the previously discarded bridge. These improvised fixes finally allowed the engineers to extend and emplace the bridge over the crossing point. With both Iraqi partners and American Soldiers looking on, the HAB settled firmly into position as darkness fell. Once engineer leaders examined the support structure and pronounced it structurally sound, the Iraqis tested the integrity of the crossing with a light truck, followed by an American mine-resistant, ambush-protected vehicle.
